# CONDITION REPORT

## STAATSOLIE V

30 JULY 2026

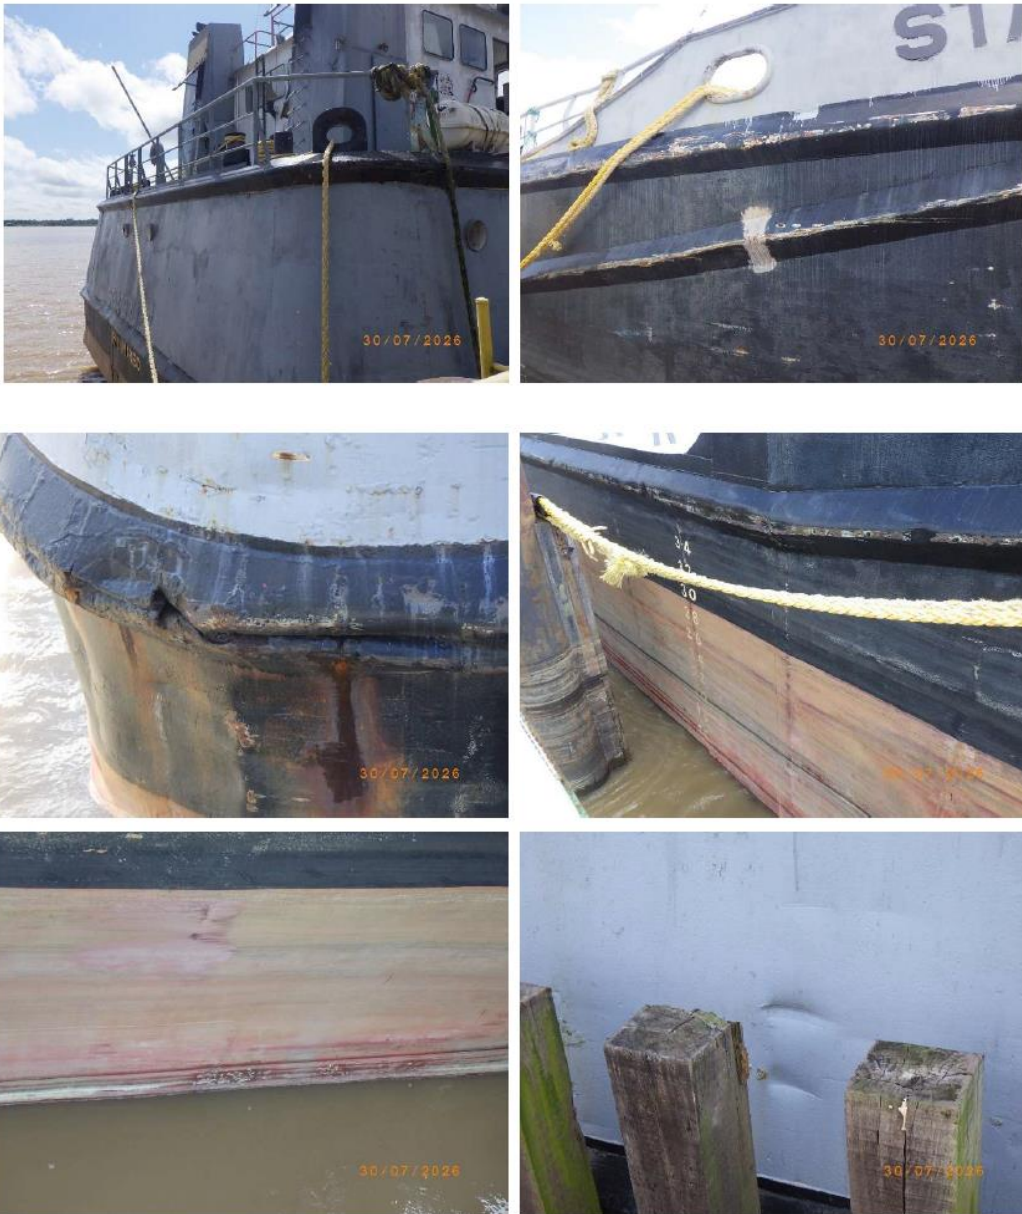
The exterior hull was found in generally good condition at the time of inspection, insofar as could be assessed above the waterline while the vessel remained afloat. The bow and stern sections exhibited only minor, non-structural denting, with no evidence of collision damage or associated structural deformation. Shell plating, weld seams, and previously fitted repair plates were assessed as being in good condition, with no visible cracking, active deformation, or significant external corrosion observed across the accessible above-waterline areas. Some marine fouling was also noted on the exterior hull at the time of inspection, consistent with normal operational wear rather than a structural concern.

*Exterior hull, port side: corrosion, defect detail deformation*

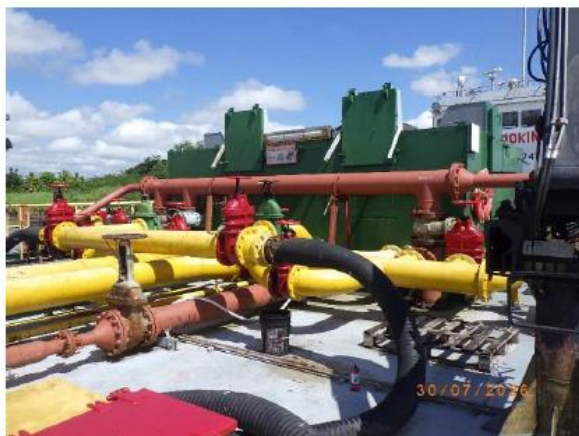
The vessel's cargo tanks are certified for carriage of petroleum products with a flashpoint above 60°C. Internal access to the cargo tanks was not possible during the inspection, as the tanks had not been gas free; consequently, the assessment of internal tank condition is based on visual observation through available access points (manholes) rather than full internal entry, and the internal coating condition could not be independently verified. This is noted as a limitation of the inspection. Within the limits of this access, no corrosion or leakage was observed at the cargo tanks, and manhole sealing was assessed as reasonable, meaning generally adequate but showing signs of wear. Tank ventilation arrangements were assessed as good. The cargo piping system — including loading and discharge lines, bunker manifolds, valves, flexible hoses, sampling systems, and drip trays — was assessed as being in good condition throughout, with no leaks or deficiencies observed. The cargo pumps were found to be in good operating condition, with no leakage observed. No functional pump test (measured versus design capacity) was carried out during the inspection.

*General overview piping and valve system on deck*

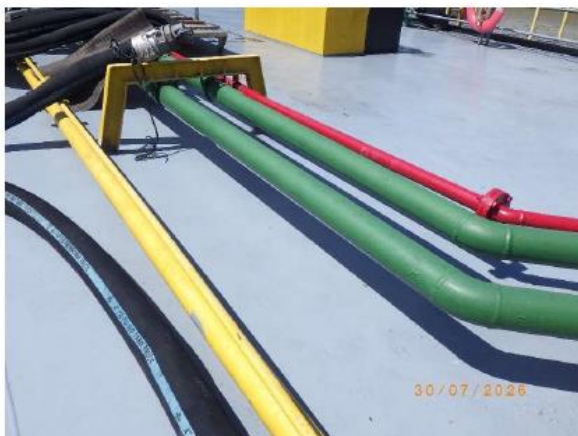
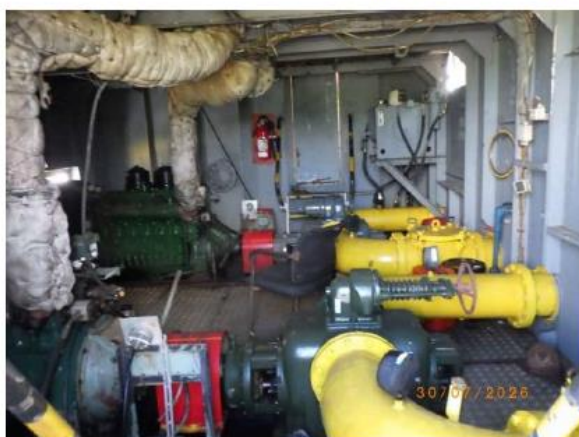
*Overview Pumproom*

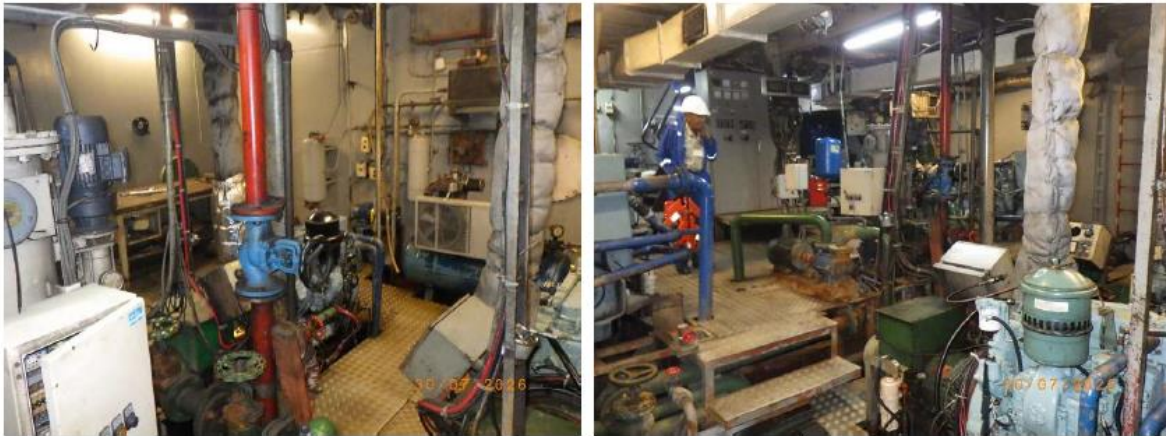
The main engines comprise two Detroit Diesel MTU S60 units (6062HK37, 4-stroke, 6-cylinder, 2,100 rpm), re-engined in 2003, with a combined output of approximately 746 kW (1,014 hp). Engine foundations and mountings were assessed as being in good condition, consistent with the overall condition of the engine room, which was found to be in good order. Electrical power is provided by two diesel generators of 69 kVA (55 kW) each, 220V/60Hz, which were found to be in good condition. The main switchboard was assessed as reasonable, indicating some wear but no significant deficiency. Batteries, battery chargers, cabling, lighting, and the alarm system were all assessed as being in good condition, with no fuel or oil leakage observed and generator foundations in good condition. No load test or insulation resistance measurement was performed on the generators during this inspection. The fire water pump was found to be in good condition. The potable water system, including the associated booster pump, was assessed as being in good condition.

*Overview Engine room with main engines and generators*

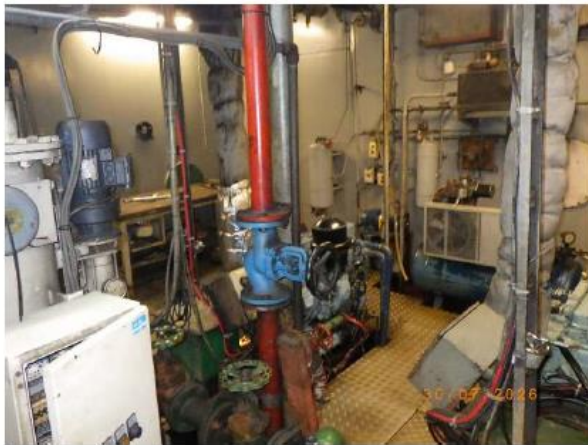
Lifebuoys were assessed as reasonable, showing wear but functional. Two life rafts were found on board but were expired at the time of inspection. Fire extinguishers, fire hoses, the fire water pump, and the fixed fire-extinguishing system were all found to be in good condition. The emergency stop arrangement on deck was found to be defective at the time of inspection and requires repair. Drip trays were in good condition.

*Firewater pump*

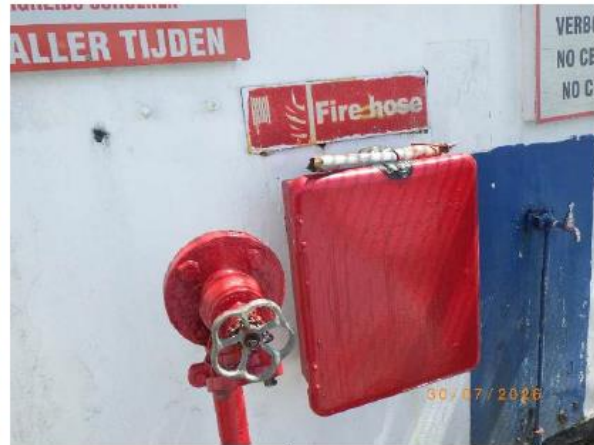
*Fire hose*

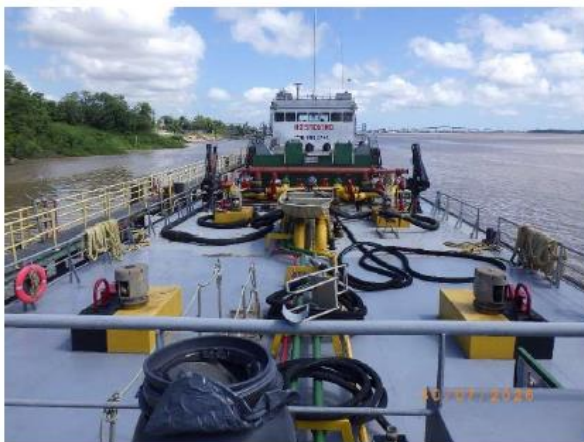
*General overview deck*

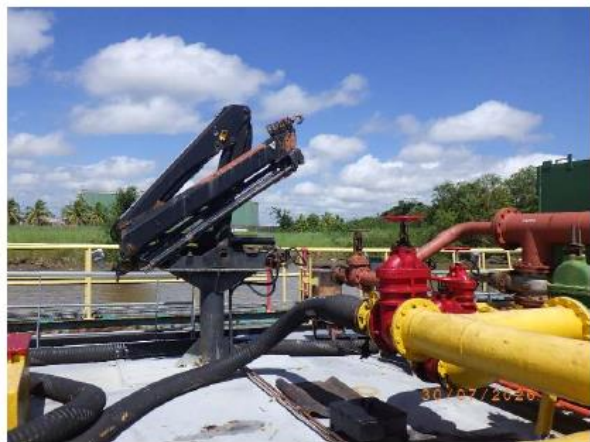
*Piping & (Hose) lifting equipment*

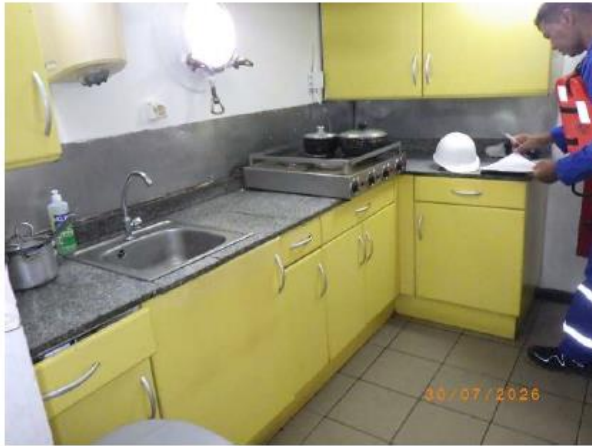
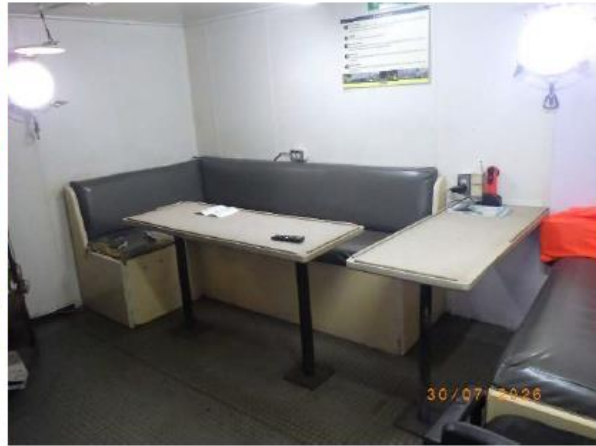
*Overview Galley and Mesroom*
